Road Safety Audit Stage 3

Isherwood Road Junction Section 106 Works

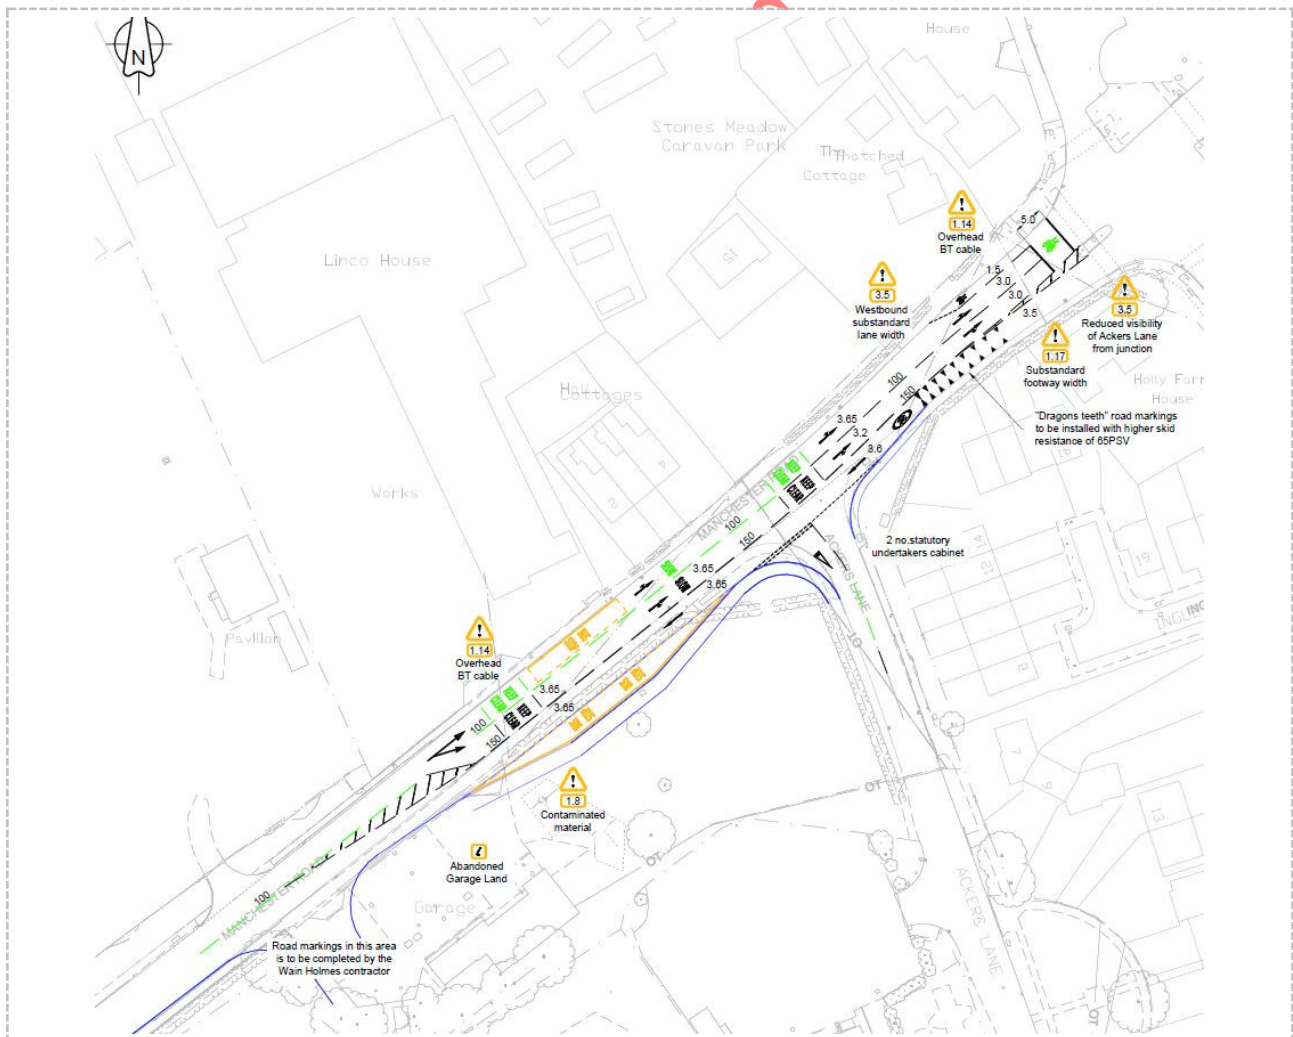
1.3. Audit Management

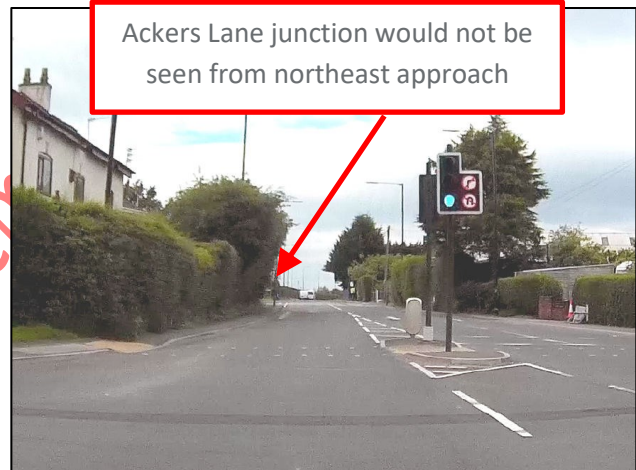
Photo 2.2-1: Ackers Lane junction would not be seen from northeast approach

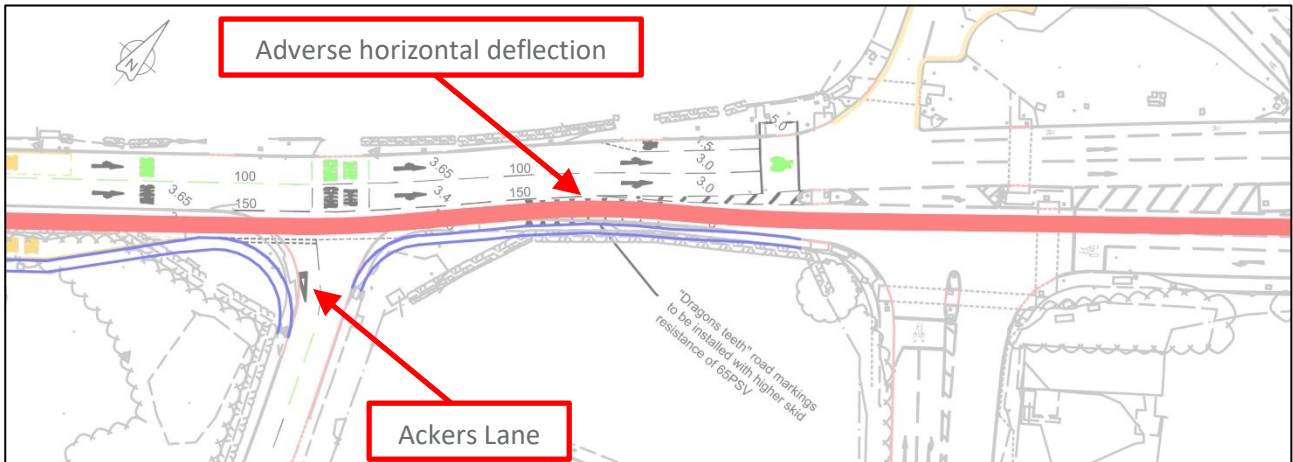
Figure 2.3-1: Adverse deflection travelling southwest through the junctions

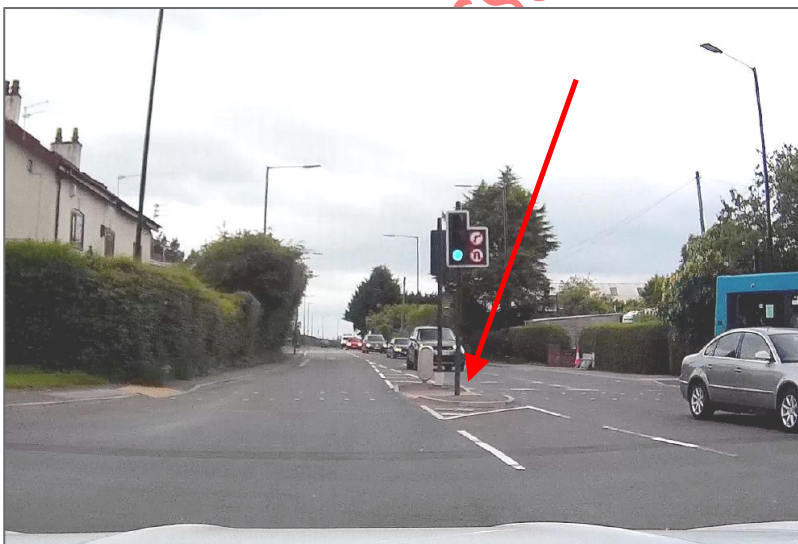
Figure 2.3-2: Adverse deflection travelling southwest through the junctions

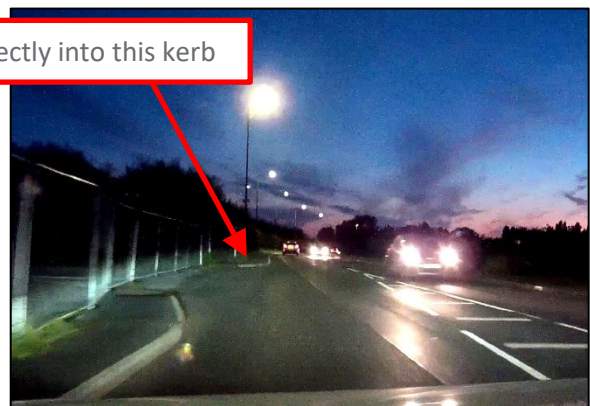
Photo 3.1-4: Western radius of unfinished bell mouth is directly ahead - night

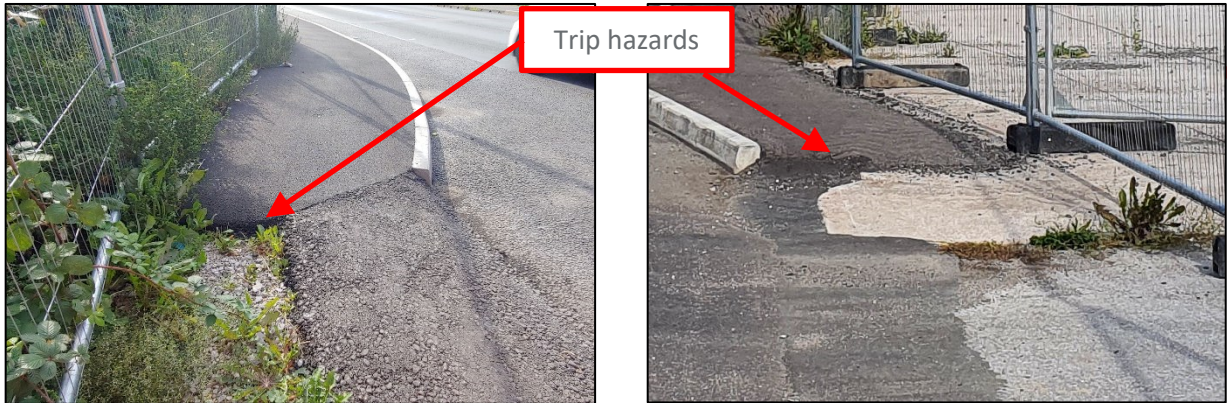
Photo 3.3-1: Western radius is in a state that presents a trip hazard

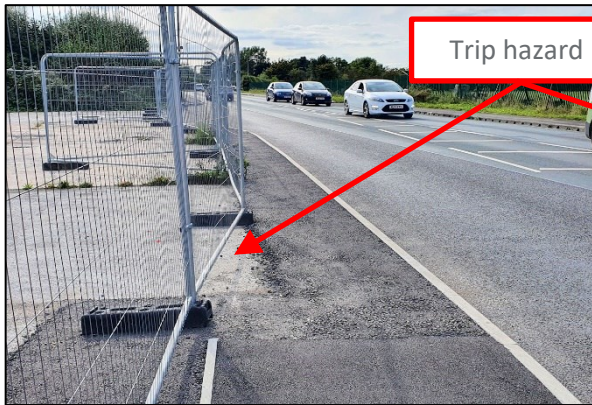
Photo 3.4-1: Footway area with trip hazard at the rear edge – facing west

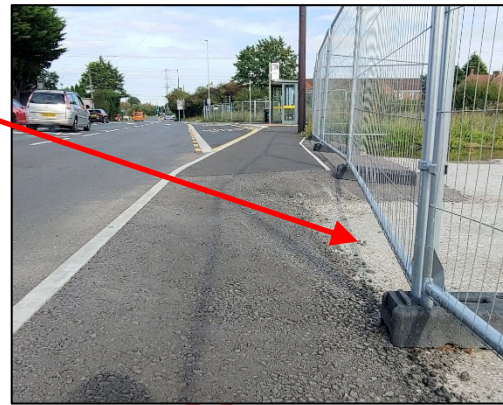
Photo 3.4-2: Footway area with trip hazard at the rear edge – facing east

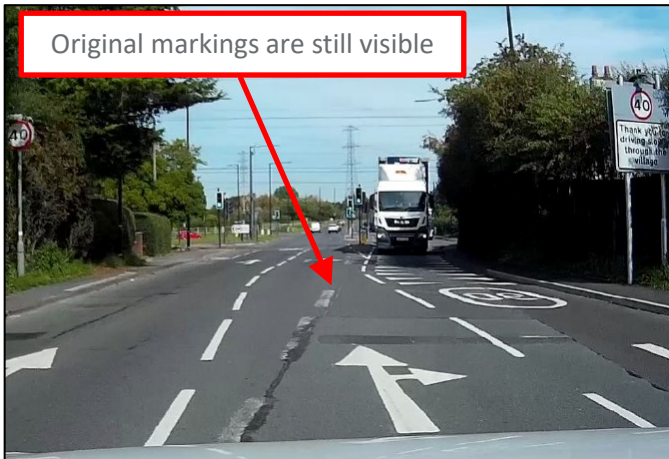
Photo 3.5-1: Original white lining showing through - eastbound

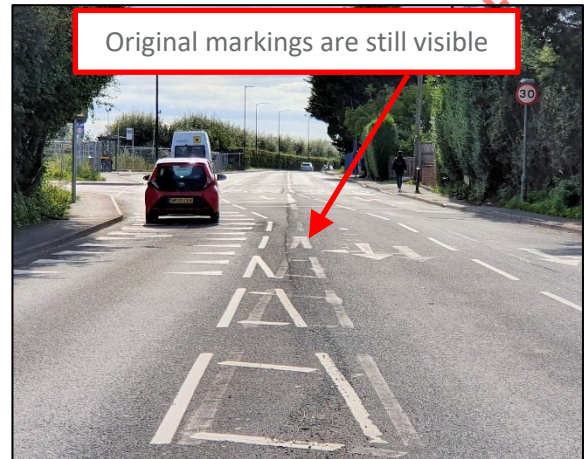
Photo 3.5-2: Original white lining showing through - westbound

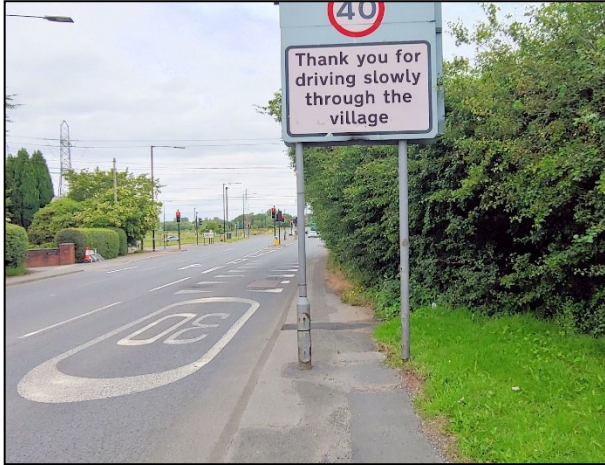
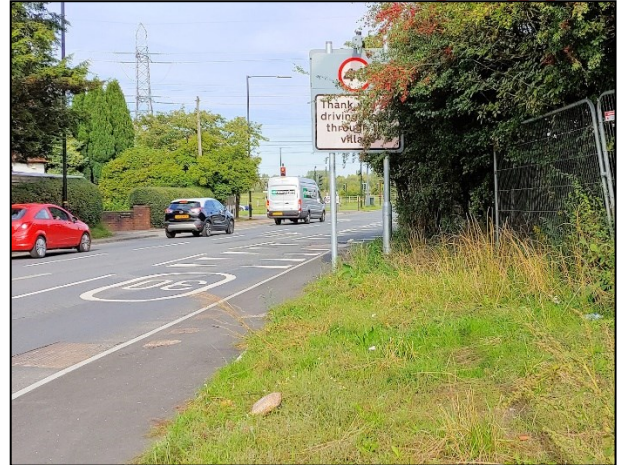
Photo 3.6-1: Intervisibility pre-scheme implementation 2020

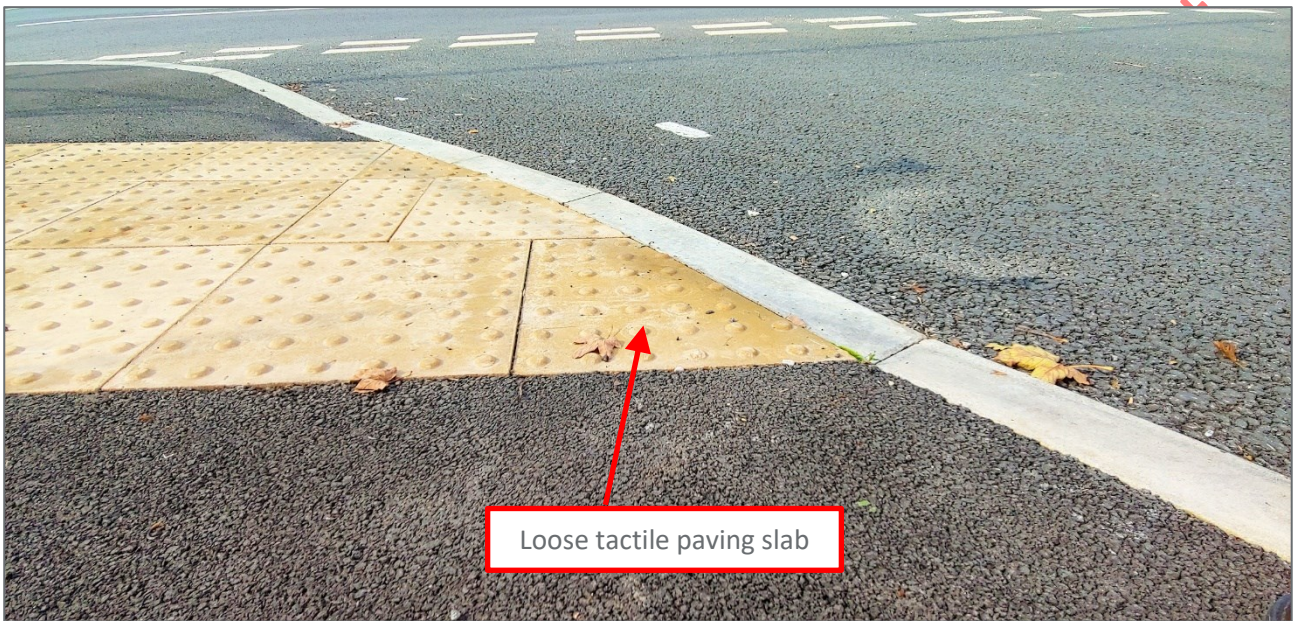
Photo 3.7-1: Loose tactile paving slab will become a slip, trip and fall hazard over a period of time
